**Preliminary Report on the accident involving a Diamond DA 42 aircraft with nationality and registration marks 5N-BNI operated by International Aviation College Ilorin, which occurred at General Tunde Idiagbon International Airport (DNIL) Ilorin, Nigeria on 23 May 2025.**

<b>Operator:</b>	International Aviation College (IAC), Ilorin
<b>Aircraft type and model:</b>	Diamond DA 42
<b>Manufacturer:</b>	Diamond Aircraft Industries GmbH, Austria
<b>Year of manufacture:</b>	2005
<b>Nationality and registration marks:</b>	5N-BNI
<b>Serial number:</b>	42.145
<b>Location:</b>	Runway 05, General Tunde Idiagbon International Airport (DNIL), Ilorin
<b>Date and Time:</b>	23 May 2025 at about 18:27 h (All times in this Report are local time, equivalent to (UTC+1) unless otherwise stated)

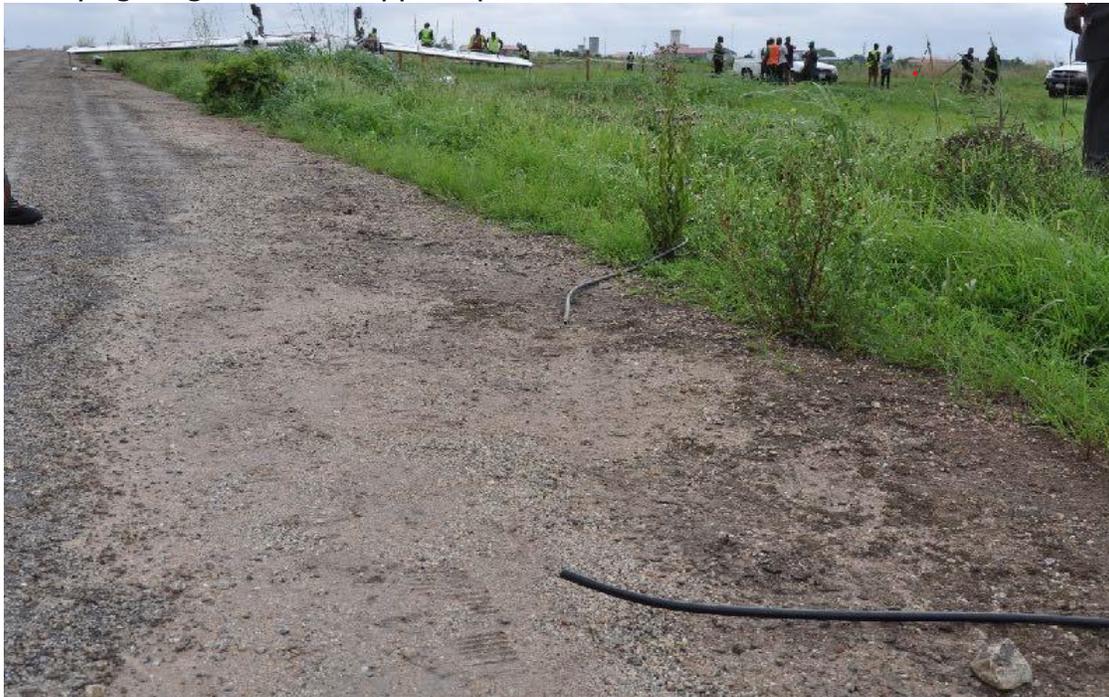
The runway lighting cable was ripped apart.

**Figure 1:** Ripped runway lighting cable

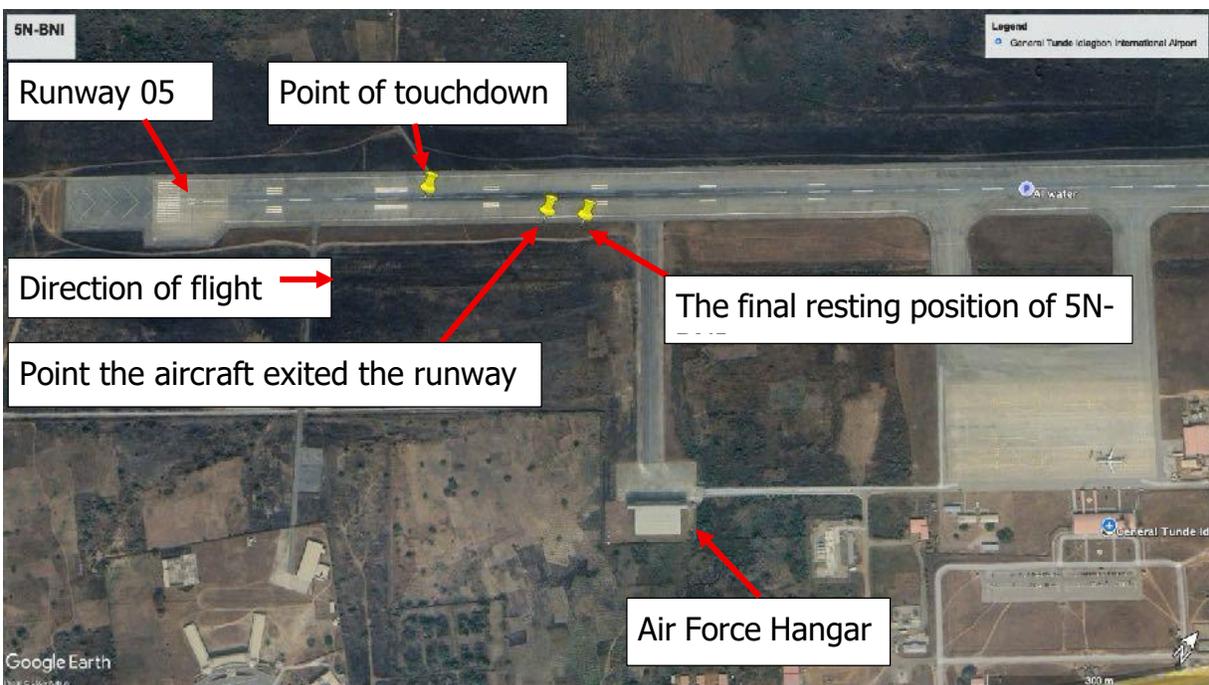
The aircraft touched down 375 m from the threshold of runway 05. Visible tyre marks were observed from the touchdown point for a distance of about 165 m, veering to the right till it exited the runway onto the grass verge. The aircraft hit an undulating surface, broke the nose landing gear and nose cone and then flipped upside down. The aircraft came to a rest about 596 m from the threshold of runway 05. There was significant damage to Left-hand (LH) propellers. Damage to the Right-hand (RH) engine and RH propellers was noticeably more severe. The tip of the left winglet was damaged. The canopy was damaged. The nose wheel was found 24 m north of the wreckage.

**Figure 2:** Google Earth view with annotations

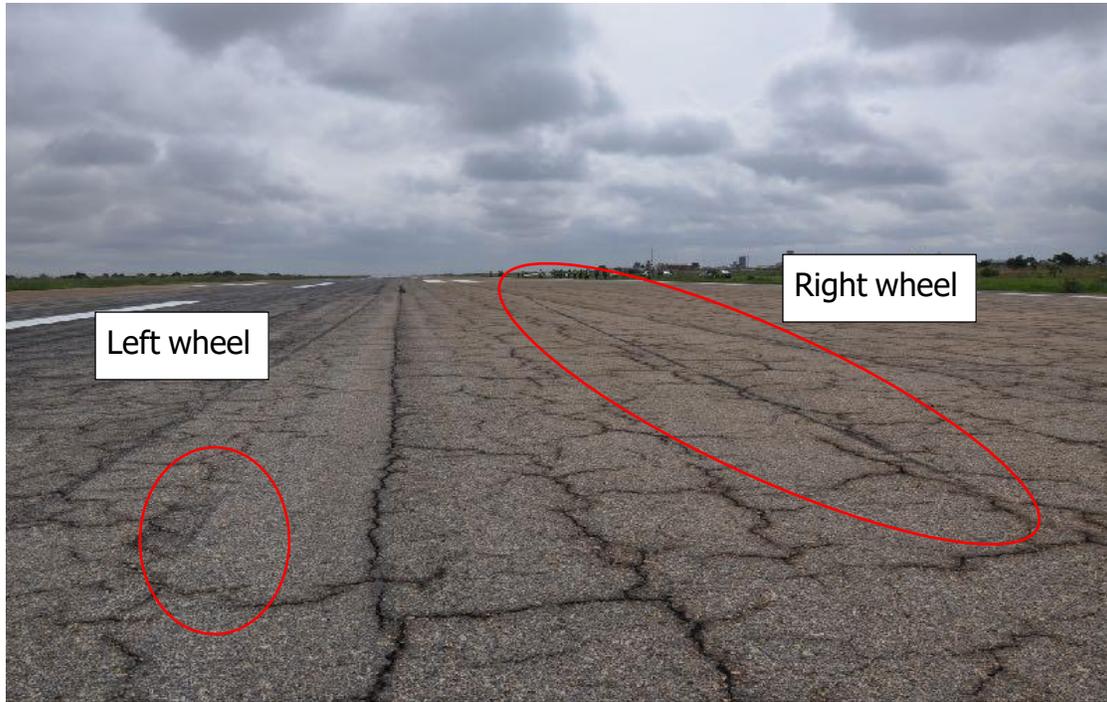
**Figure 3:** Tyre marks of touchdown point

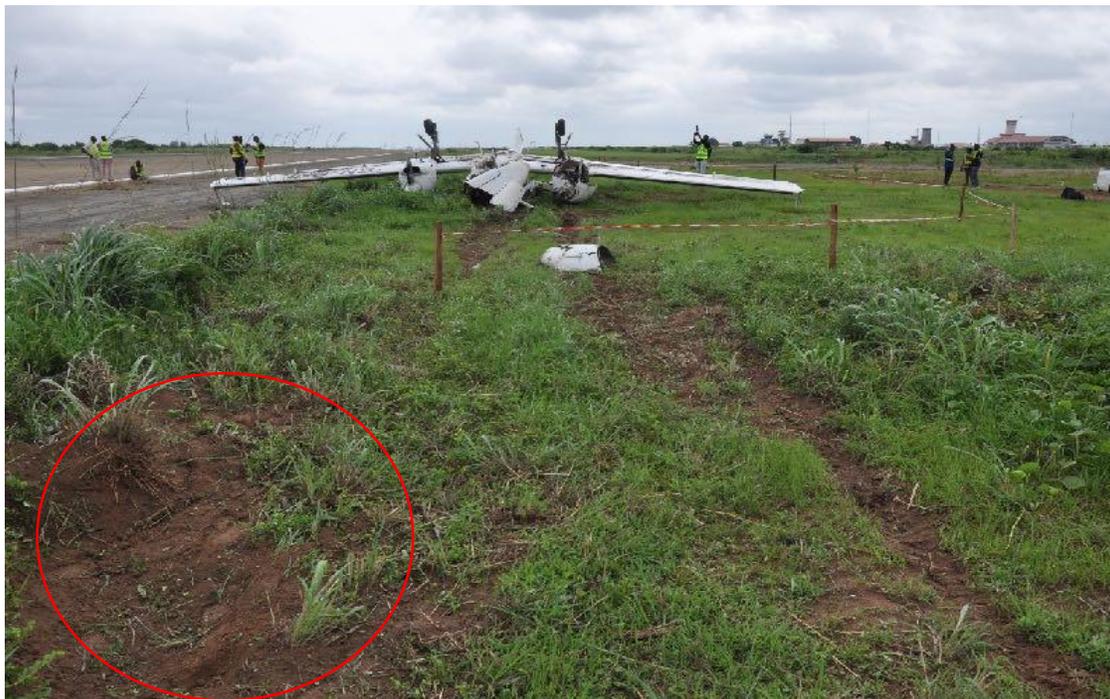
**Figure 4:** First point of impact

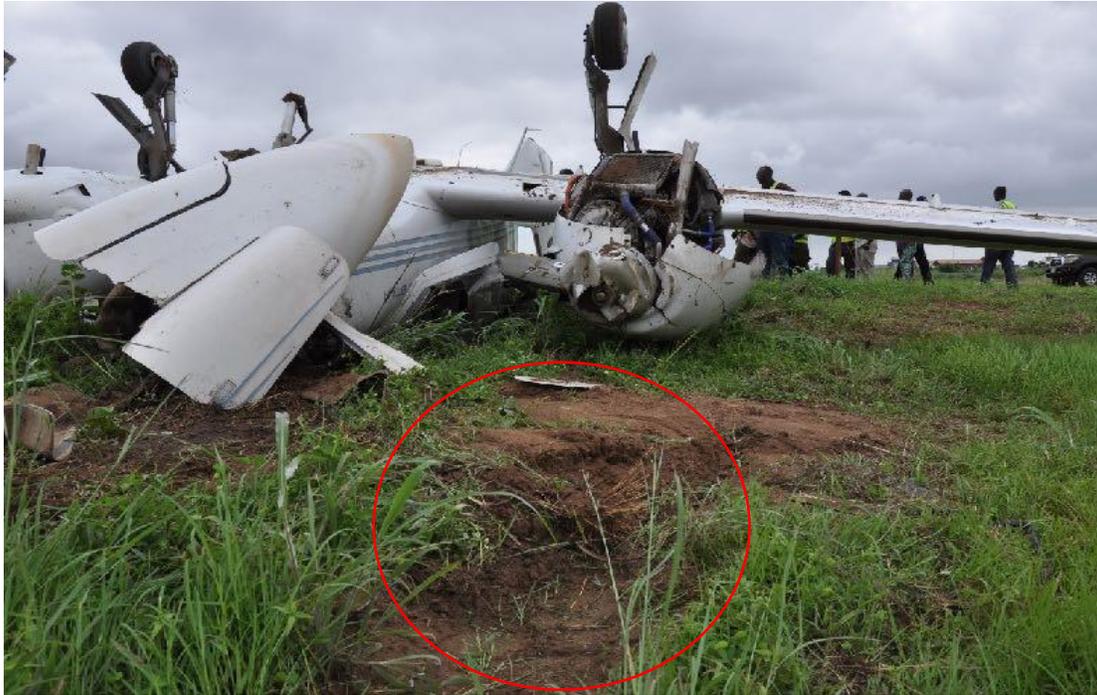
**Figure 5:** Second point of impact

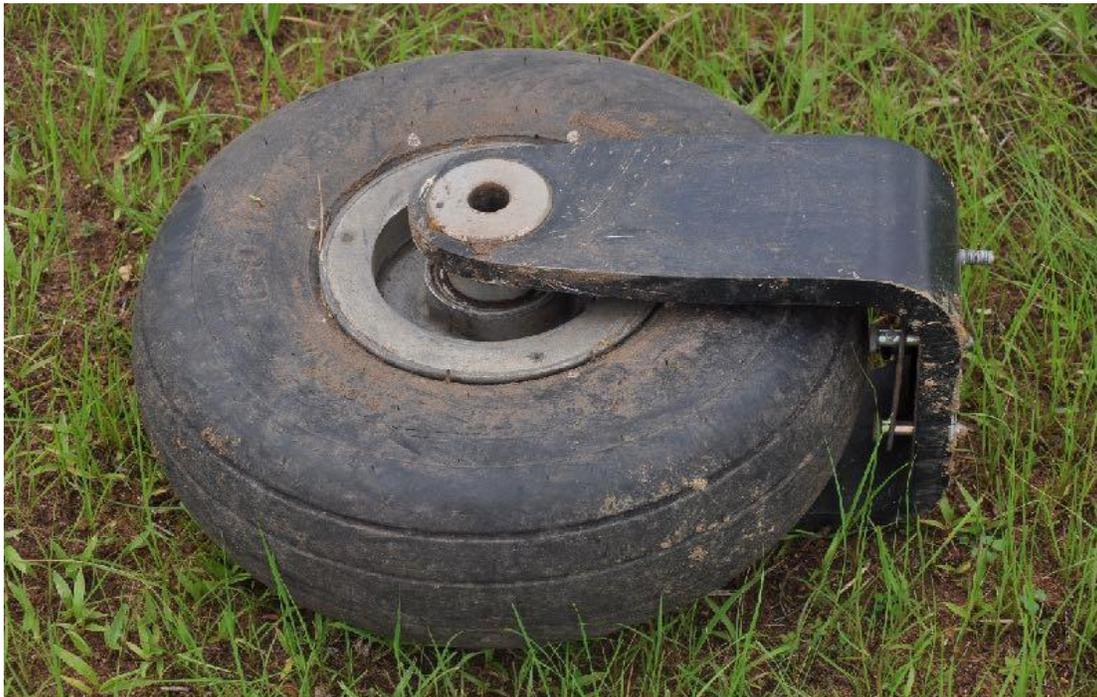
**Figure 6:** Sheared nose wheel

Landing gears: The nose cone was crushed and torn from impact. Broken Nose Gear frame and nose gear compartment. Bent nose gear fork attachment plate bolt. Damage to the nose baggage compartment. Damage to avionics relay tray.

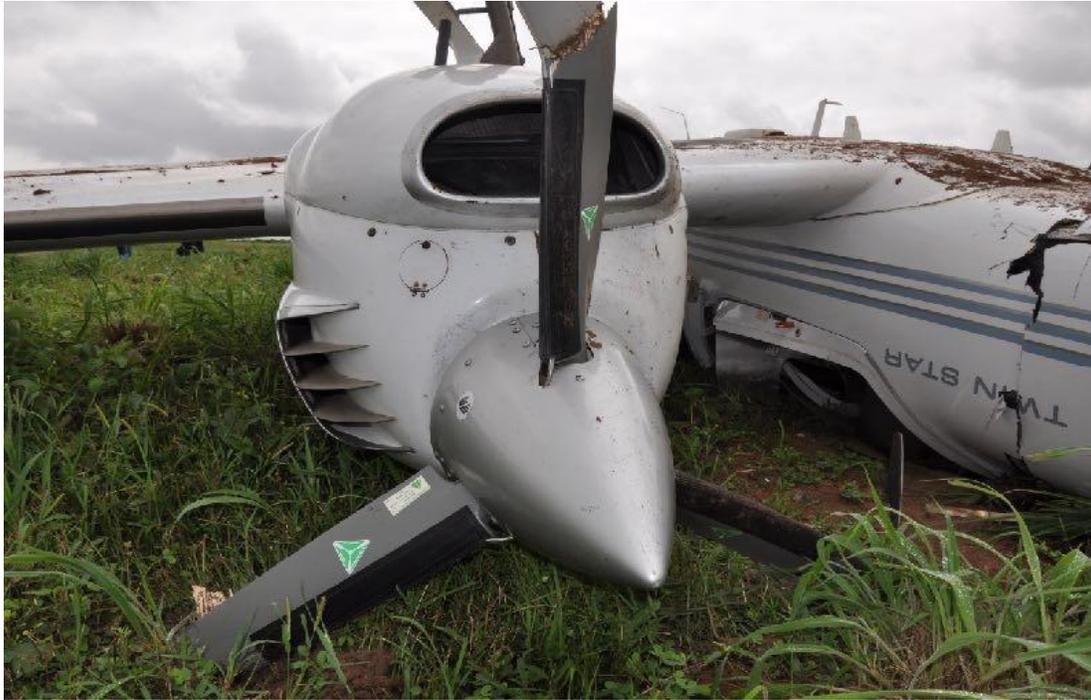
**Figure 7:** Broken propeller blades on LH engine

LH Engine & Propeller: Damage to propeller blades and gearbox.

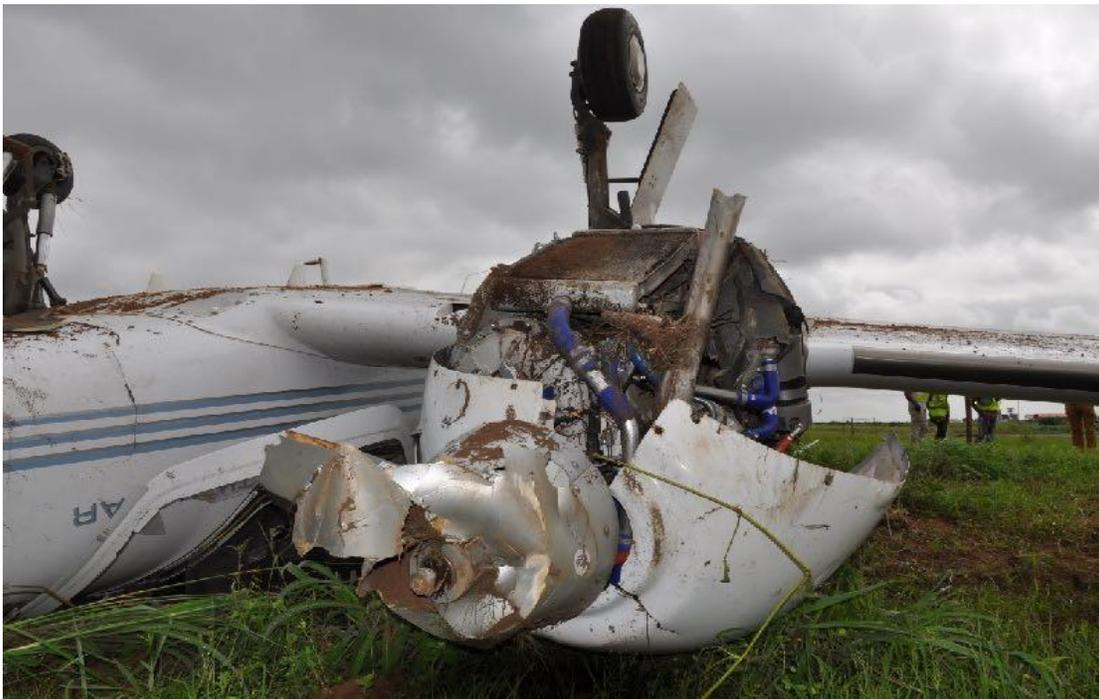
**Figure 8:** Damaged right engine cowling, propeller hub and spinner

RH Engine & Propeller: Damage to the upper and lower cowlings of the engine. The propeller blades, hub and spinner are broken. Damage to coolant radiator and cooling system components. Damage to the gearbox and exhaust pipe.

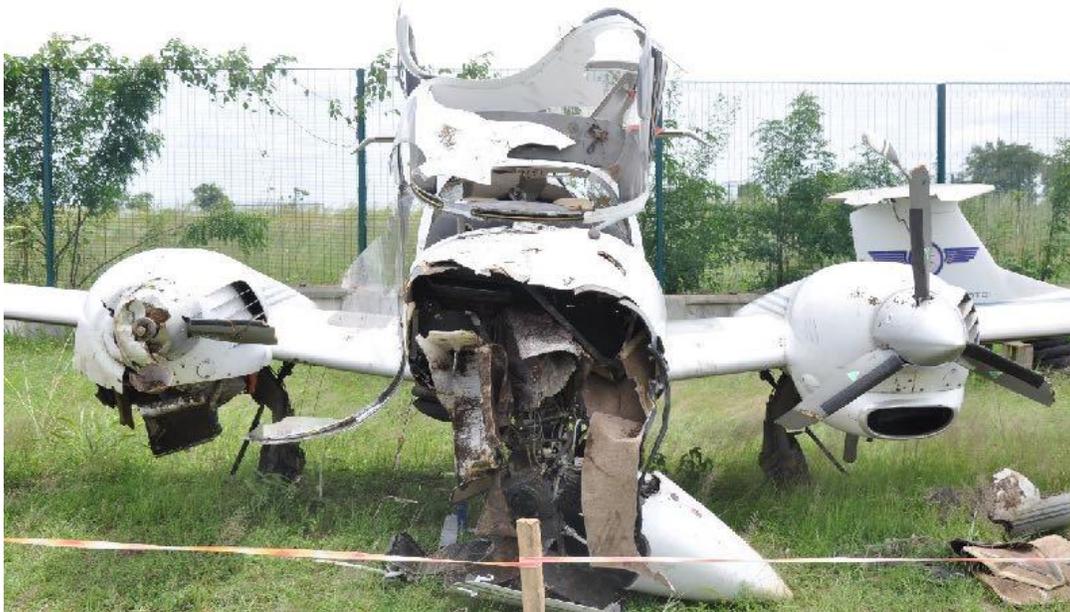
**Figure 9:** The aircraft after recovery by IAC
