**Preliminary Report on the accident involving a Diamond DA 42 aircraft with nationality and registration marks 5N-BNI operated by International Aviation College Ilorin, which occurred at General Tunde Idiagbon International Airport (DNIL) Ilorin, Nigeria on 23 May 2025.**

<b>Operator:</b>	International Aviation College (IAC), Ilorin
<b>Aircraft type and model:</b>	Diamond DA 42
<b>Manufacturer:</b>	Diamond Aircraft Industries GmbH, Austria
<b>Year of manufacture:</b>	2005
<b>Nationality and registration marks:</b>	5N-BNI
<b>Serial number:</b>	42.145
<b>Location:</b>	Runway 05, General Tunde Idiagbon International Airport (DNIL), Ilorin
<b>Date and Time:</b>	23 May 2025 at about 18:27 h (All times in this Report are local time, equivalent to (UTC+1) unless otherwise stated)

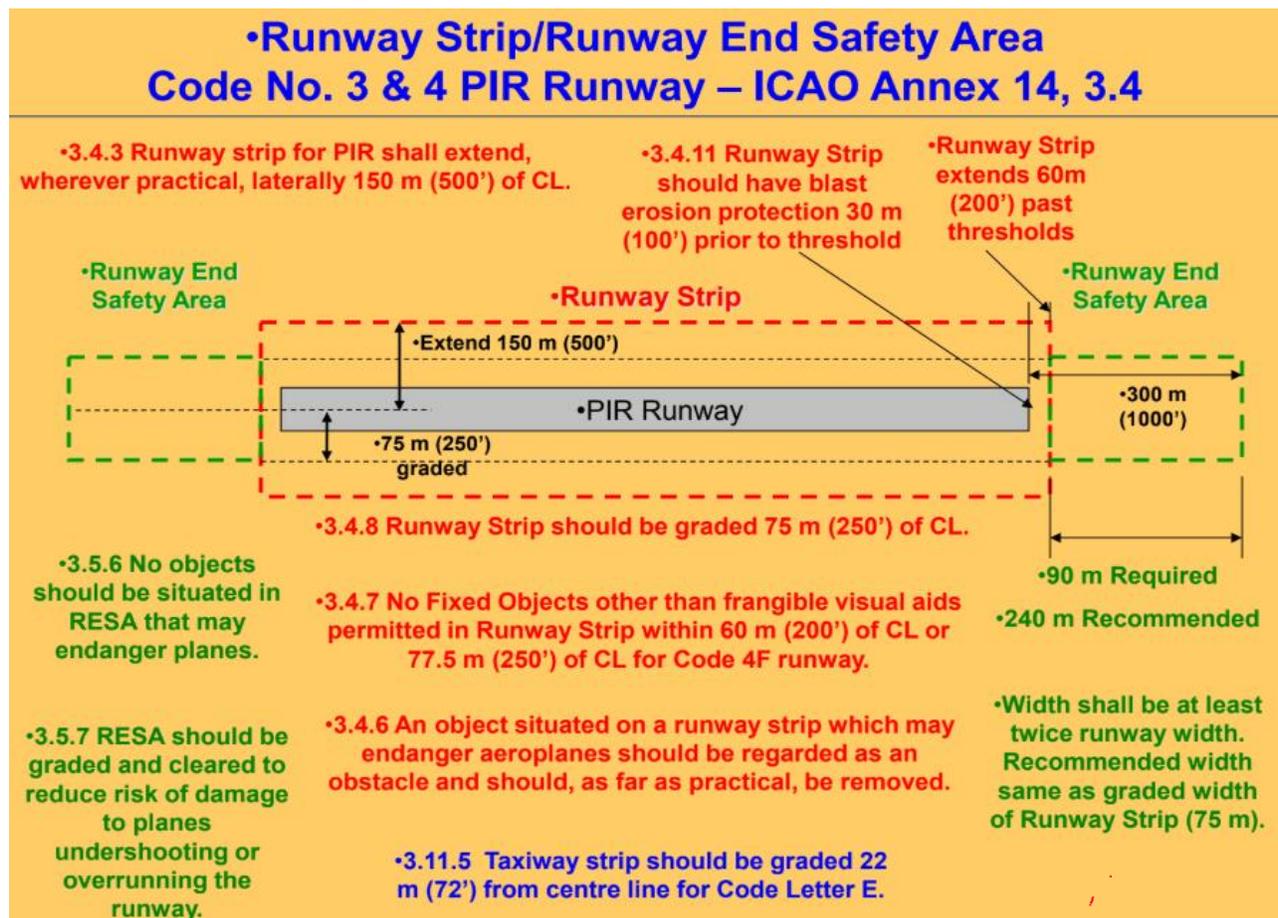
**Figure 10:** Runway Strip/Runway End Safety Area

3.4.6 Recommendation. — An object situated on a runway strip which may endanger aeroplanes should be regarded as an obstacle and should, as far as practicable, be removed.

3.4.10 The surface of that portion of a strip that abuts a runway, shoulder or stopway shall be flush with the surface of the runway, shoulder or stopway.

1. The flight crew were certified to conduct the flight.
2. The aircraft had a valid Certificate of Airworthiness.
3. The student Pilot was the Pilot flying.
4. The flight was a mock check flight in preparation for the student pilot for a Commercial Pilot License check ride.
5. ATC cleared the aircraft for RNAV approach runway 05.
6. The student was flying a simulated single engine-out approach procedure.
7. Visible tyre marks were observed from the touchdown point at a distance of about 165 m, veering to the right till it exited the runway onto the grass verge.
8. The instructor and student were rescued by Air Force personnel.
9. The instructor and student sustained minor injuries.
10. ARFFS arrived 15 minutes after the occurrence.
11. The runway lighting cable was exposed.
12. The runway strip was not flush.
